NORTH SIDE LEARNING CENTER

501 Park St. – former Holy Trinity Church

The SLPB initialed a site meeting with the Owner on May 7th 2013, to get an update on the progress of the applicant to finalize their plan for removal of (6) exterior crosses. The removal plan includes any new construction or repair work required to provide weather protection of the remaining original structure.

Removal of (4) four “Cast Stone” Crosses

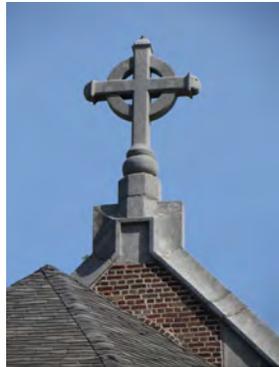
The (4) crosses at the top of the four main masonry walls, north, south, east & west, appears to be a “cast stone”, a precast concrete like material typically uses for decorative features requiring special or unique shapes.

These crosses include a “globe” base which appear to be cast in one piece.

Remove each cross, leaving the “globe” as a finial at the top of the wall. This may require a cut of the original cast cross.

If the cross removal includes the “globe’ base, then replace the cross with a precast stone “globe” of approximately the same size. as the original.

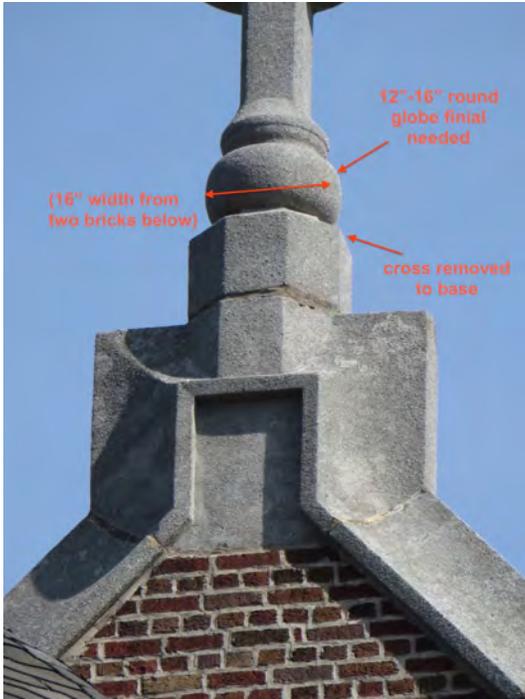
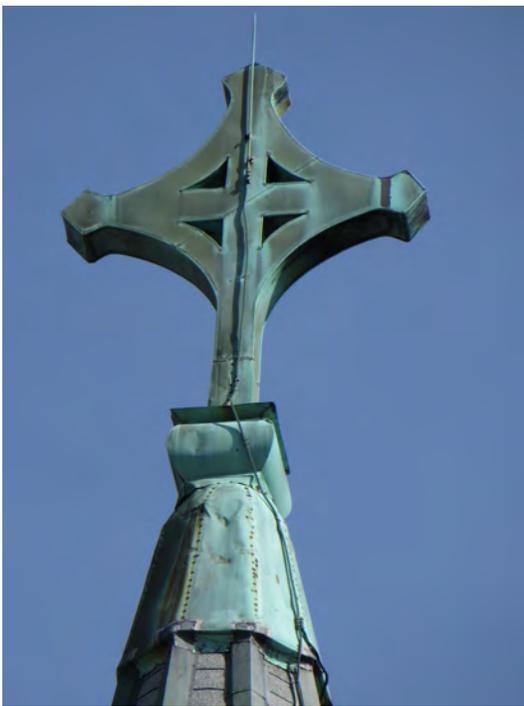
cross features appear to be cast including the lower “globe” base as one casted unit.

Option 1:

Option 2:

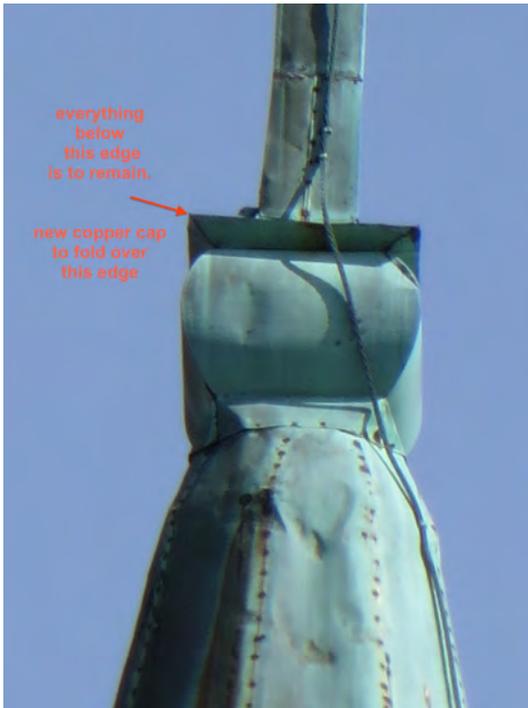
The (2) copper clad crosses, probably covering wooden form, sit atop a copper steeple cap detail.

The copper crosses are to be removed to base of the cross. The remaining copper steeple cap flashing is to remain and to be covered with a new copper cap folded over the edge of the original cross base.

All lightning rod and cable protection at all (6) cross locations is to remain functional, as verified by a lightning protection contractor or engineer.
